BACKGROUND:

TECHNIQUE:

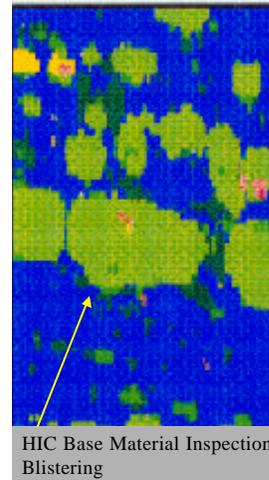
Figure 1 – Base Material Inspection Blistering

When the reflections from the blisters reach the stage shown in figure 1 above, additional shear inspection is required to determine if Step-Wise cracking is present.

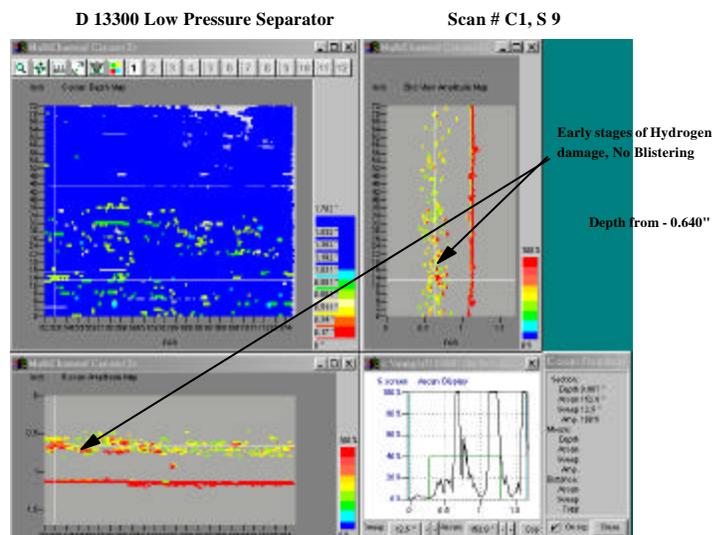
Earlier stages show no loss of “back-wall echo” as seen in figure 2.

Figure 2 – Early stages of Hydrogen damage, no blistering

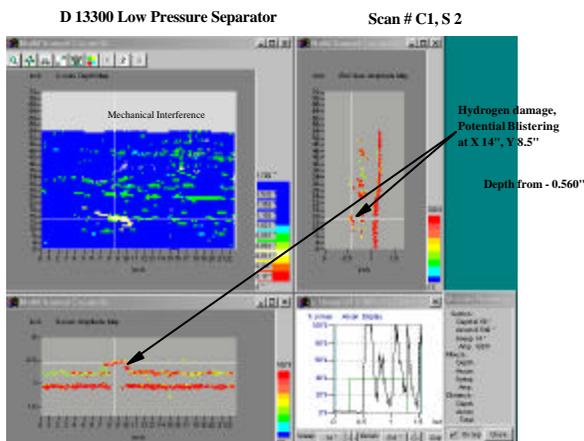
In contrast, a blister detected with compression data shows a clear loss of “back-wall echo” below the blister (see figure 3).

Figure 3 – Hydrogen Damage, Potential Blistering

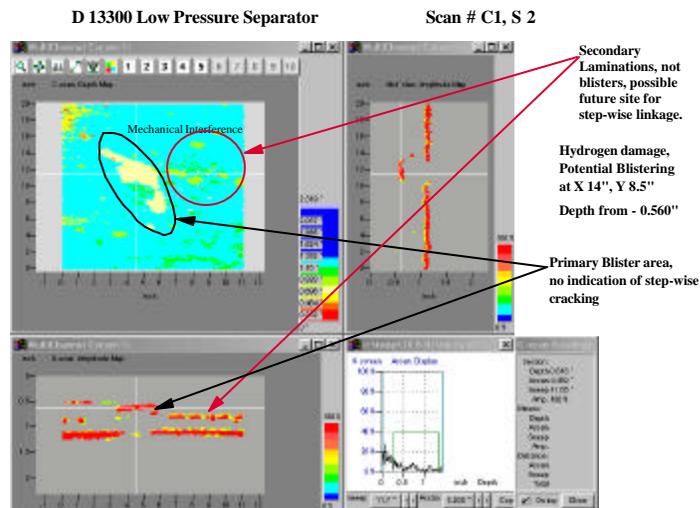
Figure 5 – Secondary Laminations, Hydrogen Damage, Primary Blister Area, no Indication of Step-Wise Cracking

In this case the high-resolution scan did not show any shear wave indications from the blister areas. A point to note is that a number of laminar indications exist adjacent to the blister. These will be likely to become a source for Step-Wise cracking at some later date.

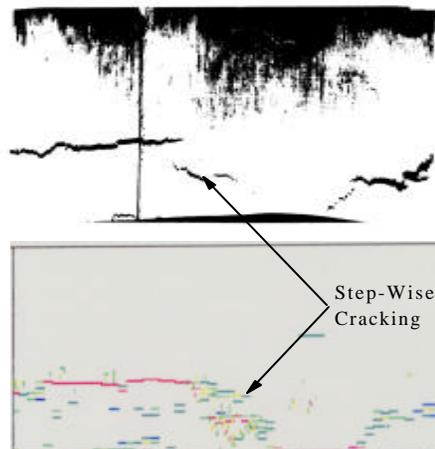
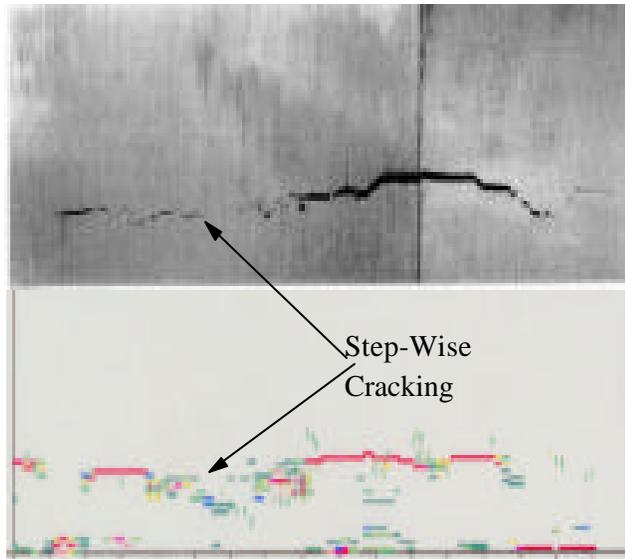
Step-Wise cracking examples are provided in the following illustrations:

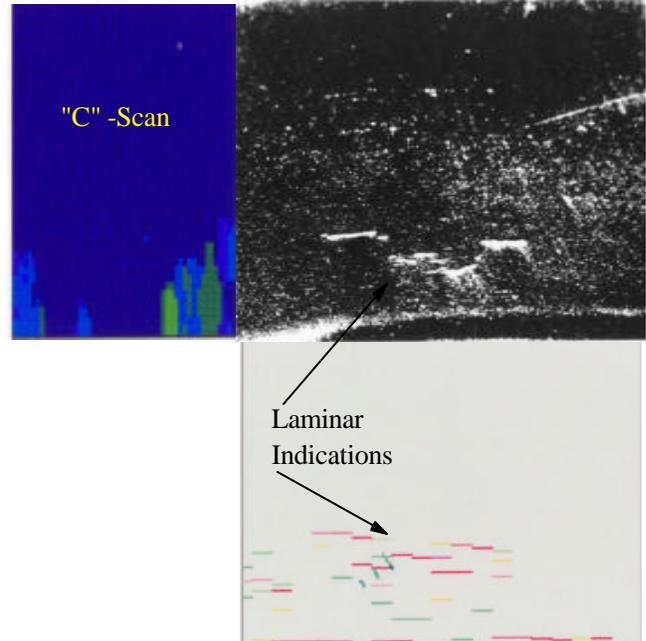
Care has to be taken in the calibration of the ultrasonic sensors as high-level gains can lead to misinterpretation of results. The following illustration shows laminar indications so fine that they could only be identified visually with fluorescent dye Penetrant.
