Capability of Ultrasonic Testing for Cast Austenitic Stainless Steel in Japanese Pressurized Water Reactors

Kazunobu SAKAMOTO^{1,*}, Takashi FURUKAWA², Ichiro KOMURA²,
Youitsu YAGIHASHI² and Tsuyoshi MIHARA³

¹Japan Nuclear Energy Safety Organization, 4-1-28, Toranomom, Minato-ku, Tokyo, 105-0001, Japan

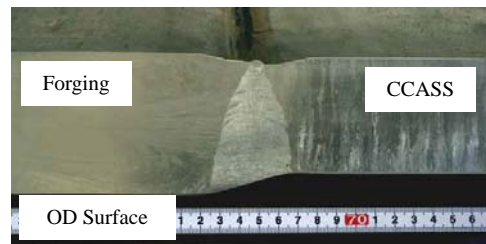
Fig. 3. KPS-04 Specimen

KPS-04 is the specimen of forged stainless steel safe-end to SCASS butt weld. KPS-05 is the specimen of CCASS to CCASS butt weld. KPS-04 and KPS-05, representing the main coolant piping system of Westinghouse PWRs in Korea, have circumferential and axial thermal fatigue cracks manufactured by Sonaspection International Ltd. Fig. 3 and Fig. 4 show the profile and flaw specification of the KPS-04 and KPS-05 respectively.

Macrograph of the cross section

Specification of flaw

Flaw location

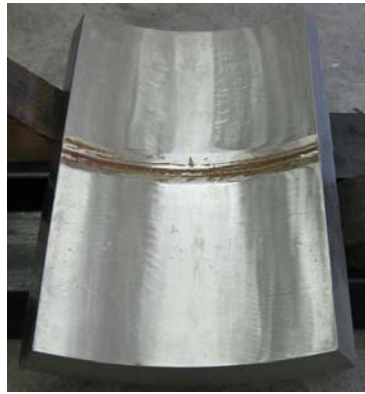
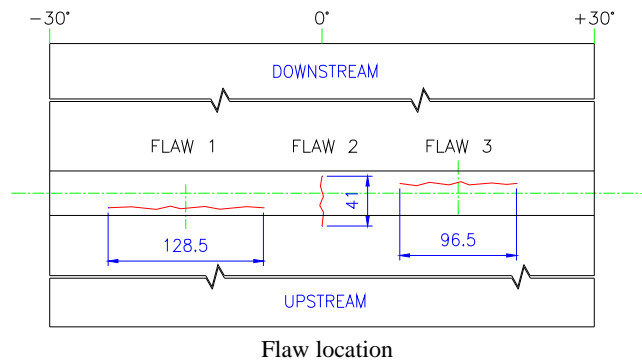
Fig. 4. KPS-05 Specimen

Macrograph of the cross section

Specification of flaw

Flaw location

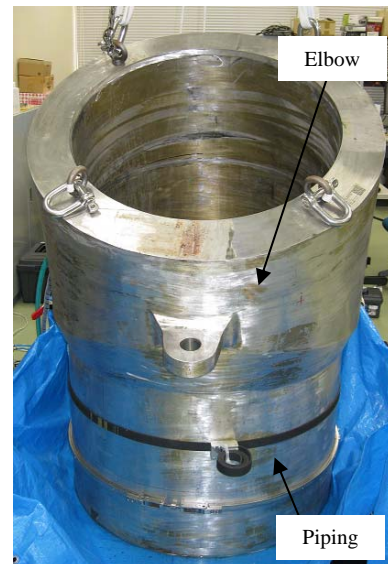
Fig. 5. Mockup A Specimen

Mockup A is the piping segment of CCASS piping to SCASS elbow butt weld by GTAW and Shielded Metal Arc Welding (SMAW) plus Submerged Arc Welding (SAW) simulating Japanese main coolant piping system as shown in Fig. 5. Fatigue cracks are induced at both sides of the weld by cyclic mechanical load. Flaw depth described in Fig. 5 is the measurement value by UT from the ID surface carried out as a finger printing.

Specification of flaw

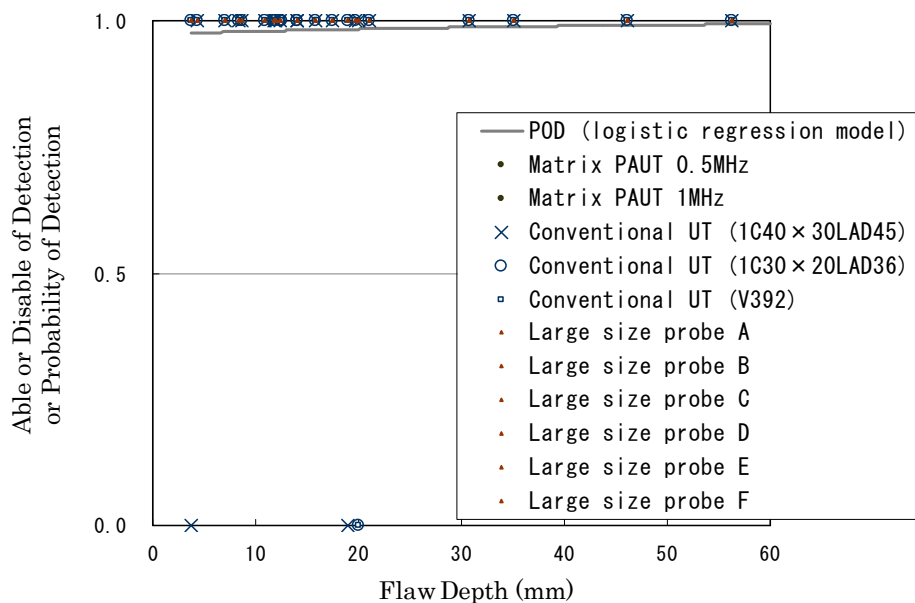
Fig. 7. Flaw depth vs. detectability

Fig. 7 shows the relationship between flaw depth and detectability together with the Probability of Detection (POD) curve obtained by logistic regression model. Although a various POD curves were proposed, a logistic regression model proposed by Pacific Northwest National Lab was applied in this study to relate POD to flaw size described as follows [14];

The minimum value of POD at the 3.8 mm of flaw depth was 0.976. The conservatism of the structure integrity for the CASS piping system postulating 60 years thermal aging with flaws of 20% wall thickness in depth and 100% wall thickness in length was verified by the research program by Japan Nuclear Energy Safety Organization [15]. Based on this knowledge, it can be said that currently available UT techniques are capable to detect the small cracks stable enough under postulated accident loads even after the thermal aging referring the POD analysis. However it should be noted that around 20mm depth fatigue cracks were not detected by some of conventional UT techniques. Considering this fact, continuous effort such as selecting the appropriate probe (e.g. PAUT probe) and training of the inspection personnel is essential, as well as the technical development to improve the flaw detection capability.

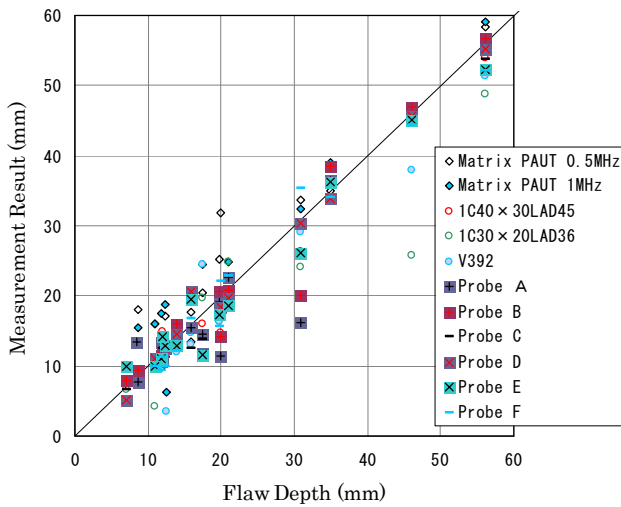
(1) All measurement methods

Fig. 9 shows the relationship between actual flaw depth and measurement result using data that was able to size. The root mean square error (RMSE) of the flaw depth sizing by all measurement techniques applied in this study was 4.1 mm.

Max. error of overestimation: 11.8mm
 Max. error of underestimation: -20.4mm
 Ave. error: -0.5mm
 Standard deviation of errors: 4.1mm
 RMSE: 4.1mm

Fig. 9. Flaw depth sizing accuracy

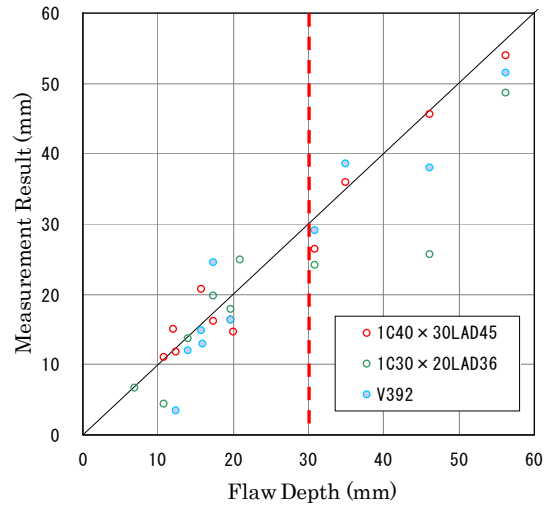
(2) Conventional UT

The RMSE by each measurement method was 5.6 mm for conventional UT, 4.5 mm for matrix PAUT, and 3.2 mm for measurement by large size probe, respectively. Measurement by large size probe showed the best result in every aspect as described in the figure among the three methods. Focusing on the measurement by large size probe, Probes C and D show the better sizing accuracy than other probes. Matrix PAUT was able to size the depth with good accuracy for deeper flaws more

Max. error of overestimation: 7.0mm
 Max. error of underestimation: -20.4mm
 Ave. error: -2.3mm
 Standard deviation of errors: 5.2mm
 RMSE: 5.6mm

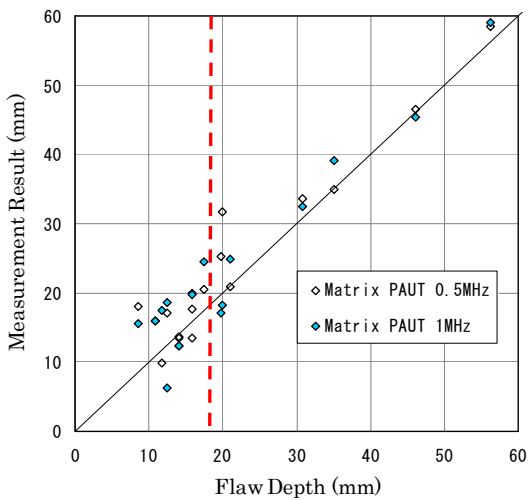
(3) Matrix PAUT

Max. error of overestimation: 11.8mm
 Max. error of underestimation: -6.3mm
 Ave. error: 2.4mm
 Standard deviation of errors: 3.9mm
 RMSE: 4.5mm

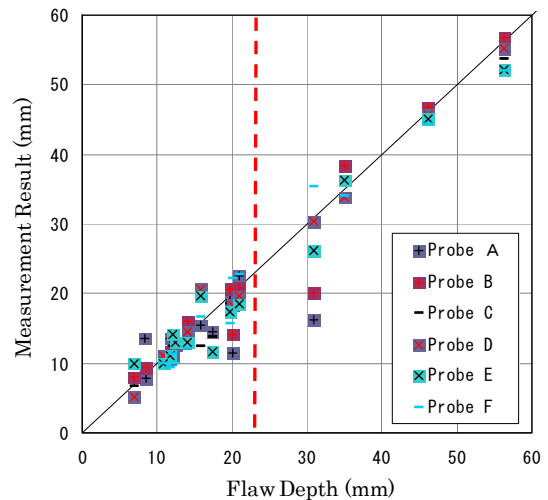
(4) UT by Large size probe

Max. error of overestimation: 5.1mm
 Max. error of underestimation: -14.6mm
 Ave. error: -1.0mm
 Standard deviation of errors: 3.0mm
 RMSE: 3.2mm

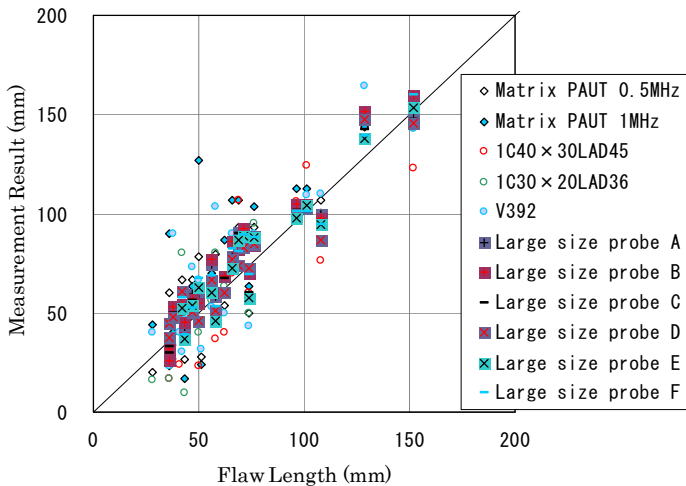
(1) All measurement methods

Fig. 10 illustrates the comparison between actual flaw length and measurement result by all applied UT techniques. The RMSE of length sizing by all measurement techniques was 16.8 mm.

Max. error of overestimation: 76.9mm
 Max. error of underestimation: -33.0mm
 Ave. error: 5.5mm
 Standard deviation of errors: 15.9mm
 RMSE: 16.8mm

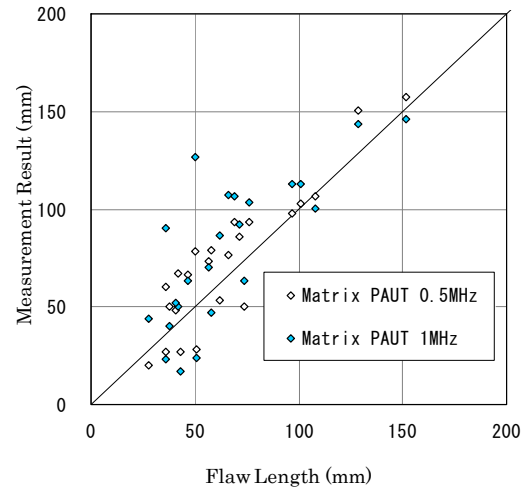
(2) Matrix PAUT

Max. error of overestimation: 76.9mm
 Max. error of underestimation: -27.0mm
 Ave. error: 9.9mm
 Standard deviation of errors: 20.8mm
 RMSE: 22.8mm

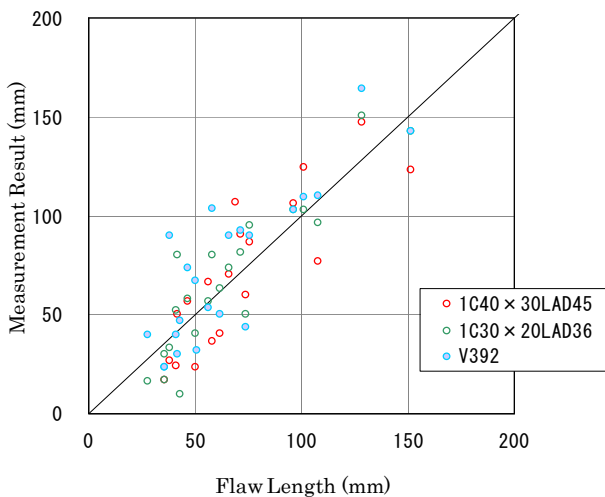
(3) Conventional UT

Max. error of overestimation: 52.2mm
 Max. error of underestimation: -33.0mm
 Ave. error: -2.0mm
 Standard deviation of errors: 19.9mm
 RMSE: 20.0mm

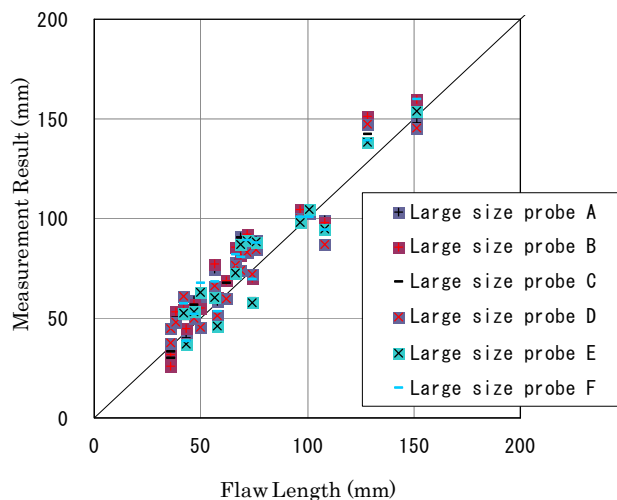
(4) UT by Large size probe

Max. error of overestimation: 23.1mm
 Max. error of underestimation: -21.1mm
 Ave. error: 5.5mm
 Standard deviation of errors: 9.7mm
 RMSE: 11.1mm
