BACKGROUND:

TECHNIQUE:

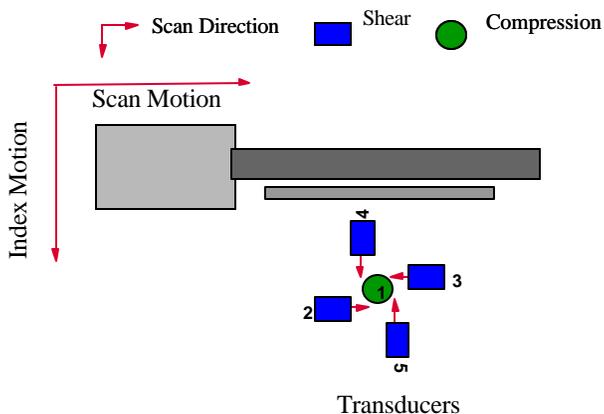
Figure 4 – Special Array used to determine Step – Wise Cracking

This was then re-inspected with a special array (figure 4) to determine if Step-Wise cracking was present (figure 5).
